NPIC/R-90/64 February 1964

PHOTOGRAPHIC INTERPRETATION REPORT

SA-1 SAM SITES, MOSCOW, USSR, SOUTHEAST QUADRANT

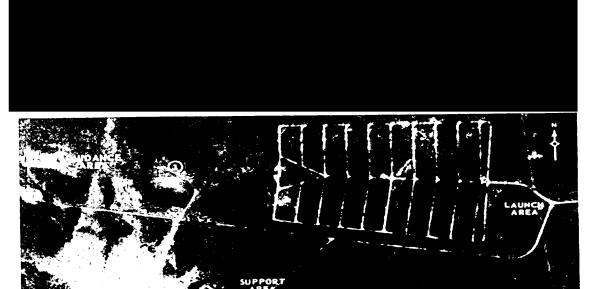
FIGURE 2. MOSCO# SAM SITE C10-1,

The first clear coverage of the site on KEYHOLE photography was in ______ at which time the site was complete. At that time, a small unidentified building (Figure 2, Item 1) was observed in a clearing midway between the guidance and launch areas. No other apparent changes were observed at the site between

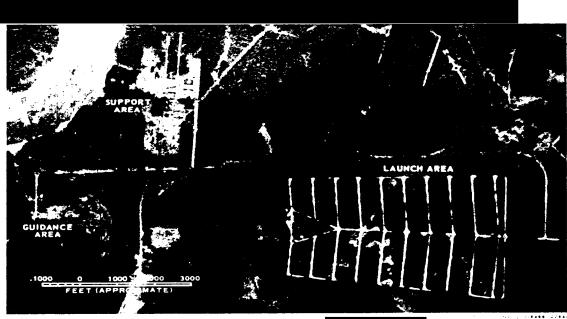
FIGURE 3. MOSCO# SAM SITE C12-1,

The first clear coverage of the site on KEYHOLE photography was in _____ at 25X1D

which time the site was complete. No apparent changes were observed at the site between

(Figure 3). **25X1D**

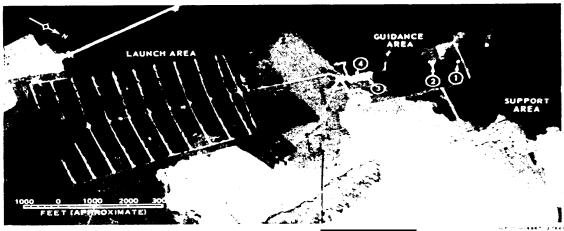
FIGURE 4. MOSCON SAM SITE C14-1,

KEYHOLE photography was in which time the site was complete. On two cleared areas (Figure 4, Items 1 and 2) were first observed. Later, on a third clearing (Item 3), 580 by 230 feet, containing several small structures was identified. A building (Item 4) 100 by 25 feet, which was under construction in had been com-

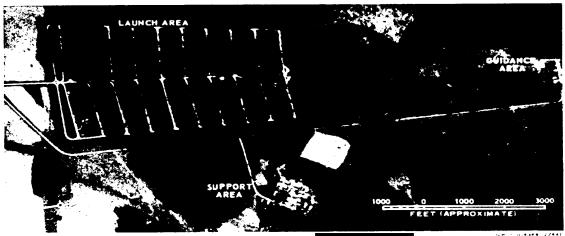
FIGURE 5. MOSCOW SAM SITE C16-1,

The first clear coverage of the site on KEYHOLE photography was in which time the site was complete. No apparent changes were observed at the site between

(Figure 5).

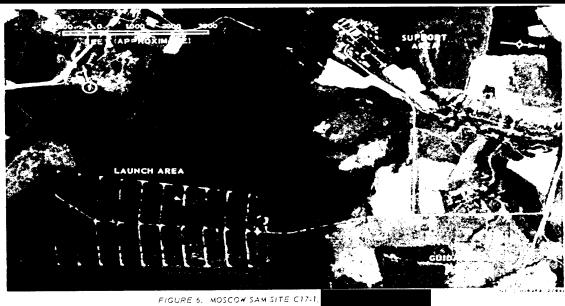
KEYHOLE photography was in which time the site was complete. On photography of ______ a road (Figure 6, Item 1) 25X1D was first observed under construction just west of the launch area. As of struction of the road had progressed, but had not been completed. No apparent changes were observed at the site between

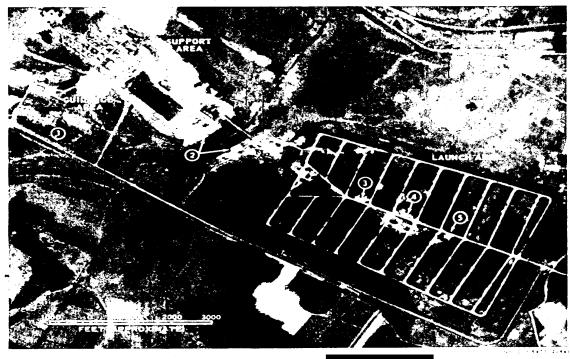
FIGURE 7. MOSCOW SAM SITE E10-1,

The first clear coverage of the site on KEYHOLE photography was in which time the site was complete. At that time,

three large warehouse-type buildings and several smaller, unidentified buildings (Figure 7, Item 1) were observed just south of the guidance area. In addition, an area of disturbed earth, but without any discernible structures, was observed on both sides of a stream (Item 2). Later, in two additional areas (Ferns 3 and 5) of disturbed earth and one small unidentified building (Item 4) were observed. No apparent 25X1D changes were observed at the site between

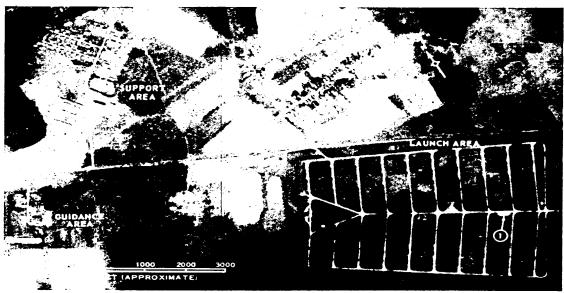
FIGURE 9. MOSCOW SAM SITE E12-1,

The first clear coverage of the site on KEYHOLE photography was in which time the site was complete. Other than minor ground scarring (Figure 9, Item 1) observed at the centerline road of the launch area, no significant changes were observed between

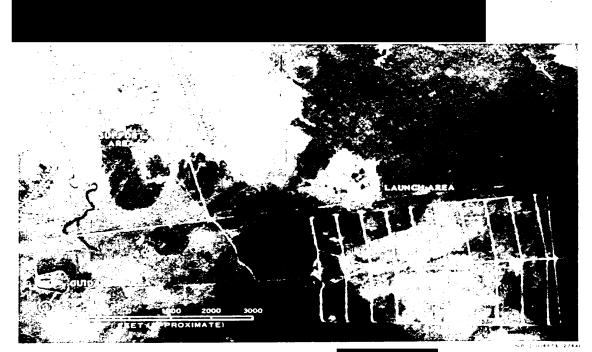
FIGURE 10. MOSCOW SAM SITE E13-1,

KEYHOLE photography was in which time the site was complete. At that time, it was noted that an earthen wall (Figure 10), Item 1) had been constructed on three sides of the guidance area, possibly to prevent flooding of the area in inclement weather. No apparent changes were observed at the site between

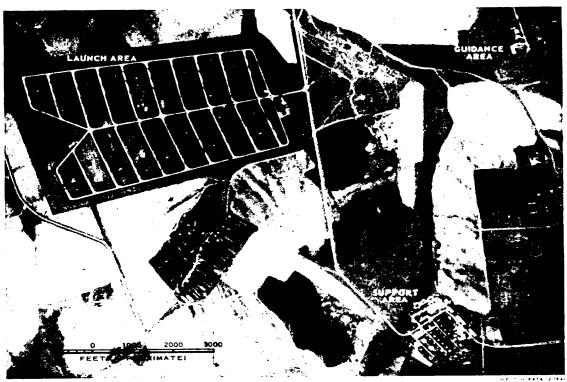
FIGURE 11. MOSCOW SAM SITE E14-1,

The first clear coverage of the site on KEYHOLE photography was in at which time the site was complete. No apparent changes were observed at the site between

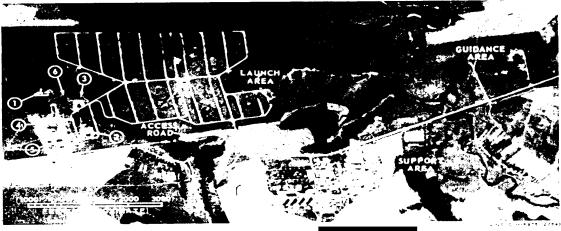
FIGURE 12. MOSCOW SAM SITE E15-1.

The first clear coverage of the site on KEYHOLE photography was in at which time the site was complete, but some additions were observed in the support area and the site facilities. Four large buildings, 195 by 40 feet, had been constructed in the support area and an access road was under construction parallel to the launch area. Between

construction activity, possibly AMM associated, was observed at the southeast corner of the launch area. In a fifth 195- by 40-foot building had been added to the

support area and an unidentified ground pattern (Figure 12, Item 1) was observed near the centerline of the launch area. Later in a sixth 195- by 40-foot building was identified in the support area and two buildings (Items 2 and 3), 100 by 100 feet, with objects on the roofs had been constructed at the southeast corner of the launch area. The walls of a rectangular building (Item 4) were under construction just south of the 100- by 100-foot buildings.

In addition to the above changes, four buildings (Item 5), 110 by 35 feet, 95 by 30 feet, 85 by 30 feet and 55 by 25 feet, had been observed under construction on photography.

These buildings were completed by

the rectangular building 225 by 125 feet (item 4) had been completed and a plus-configuration scar (Item 6), possibly ditching for cable connections, was observed at the south side of the launch area.

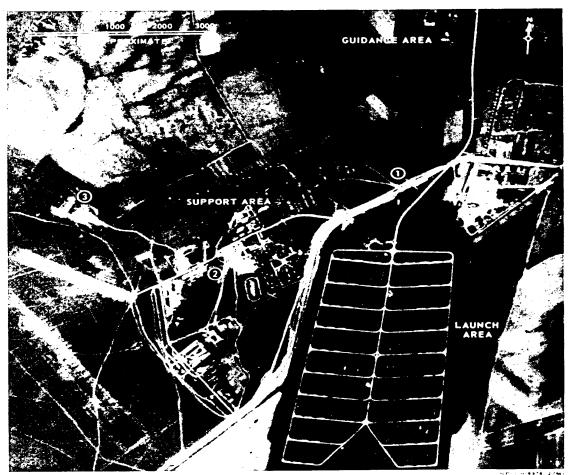
FIGURE 13. MOSCO# SAM SITE E16-1,

MOSCOW SAM SITE E16-1 25X1D 25X1A 25X1D BE No: The first clear coverage of the site on NPIC Target No: 0167-122-F KEYHOLE photography was in Coords: 55-05N 38-10N which time the site was complete. At that time, 25X1D Map Ref: DIA Sheet 0167-10HL, Feb 63 (S) a road (Figure 13, Item 1) was under construc-25X1D First KEYHOLE coverage: tion. In , two earth scars (Items 2 and 3) were observed. No other significant Status then: changes were observed at the site between undetermined because of haze and darkness 25X1D 25X1D
